# Thermography Inspection Report

Thermography Inspection  
at  
Sample Location

Date:  
1<sup>st</sup> January 2004

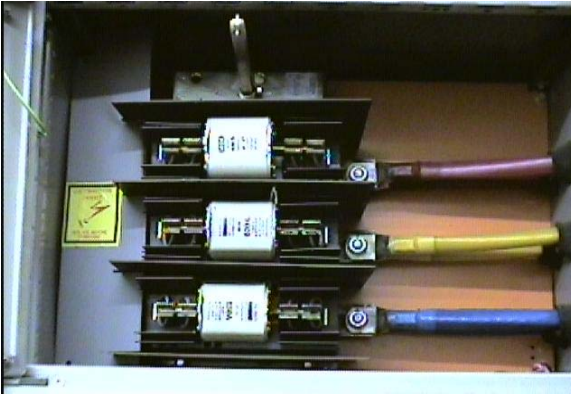
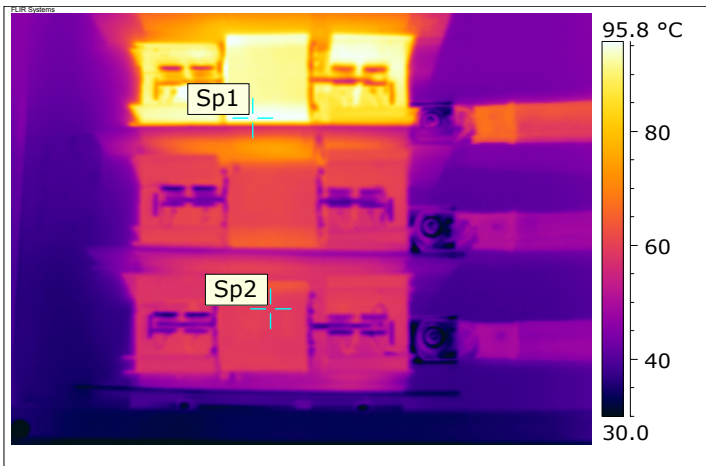
IR Text Comment	Value
Location	Main Switch Board No. 2
Equipment	Tenants Sub Switch Board
Description	Switchfuse
Nom load	630A
Actual load	520A (approx)
Fault	<b>2</b>
Recommendation	Repair at scheduled shut down

Label	Value
Sp1	96.0 °C
Sp2	59.3 °C

<b>Temp rise (Sp1 – Sp2)</b>	<b>36.6 °C</b>
------------------------------	----------------

Excessive heat has been noticed on the outgoing switchfuse. On further examination it is deemed necessary to replace this switchfuse.

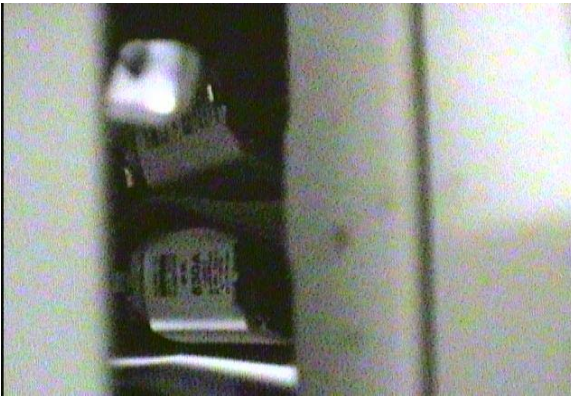
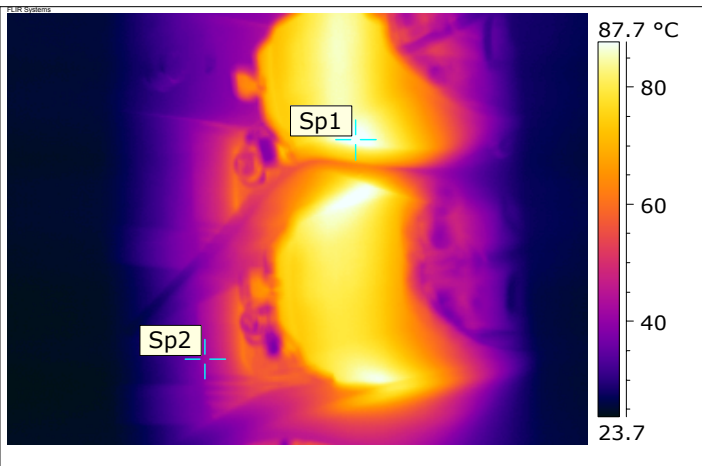
IR Text Comment	Value
Location	Main Switch Board No. 2
Equipment	Supermarket
Description	Switchfuse
Nom load	630A
Actual load	520A (approx)
Fault	<b>3</b>
Recommendation	Repair immediately

Label	Value
Sp1	88.4 °C
Sp2	42.0 °C

<b>Temp rise (Sp1 – Sp2)</b>	<b>46.4 °C</b>
------------------------------	----------------

Excessive heat has been noticed on the outgoing switchfuse. On further examination it is deemed necessary to replace this switchfuse.
